Mill-Cedar Meadow Restoration

March 14, 2003

Meadow Site Description – Mary’s Peak Resource Area, Salem District BLM

Landmark Name: **Mill-Cedar Creek**

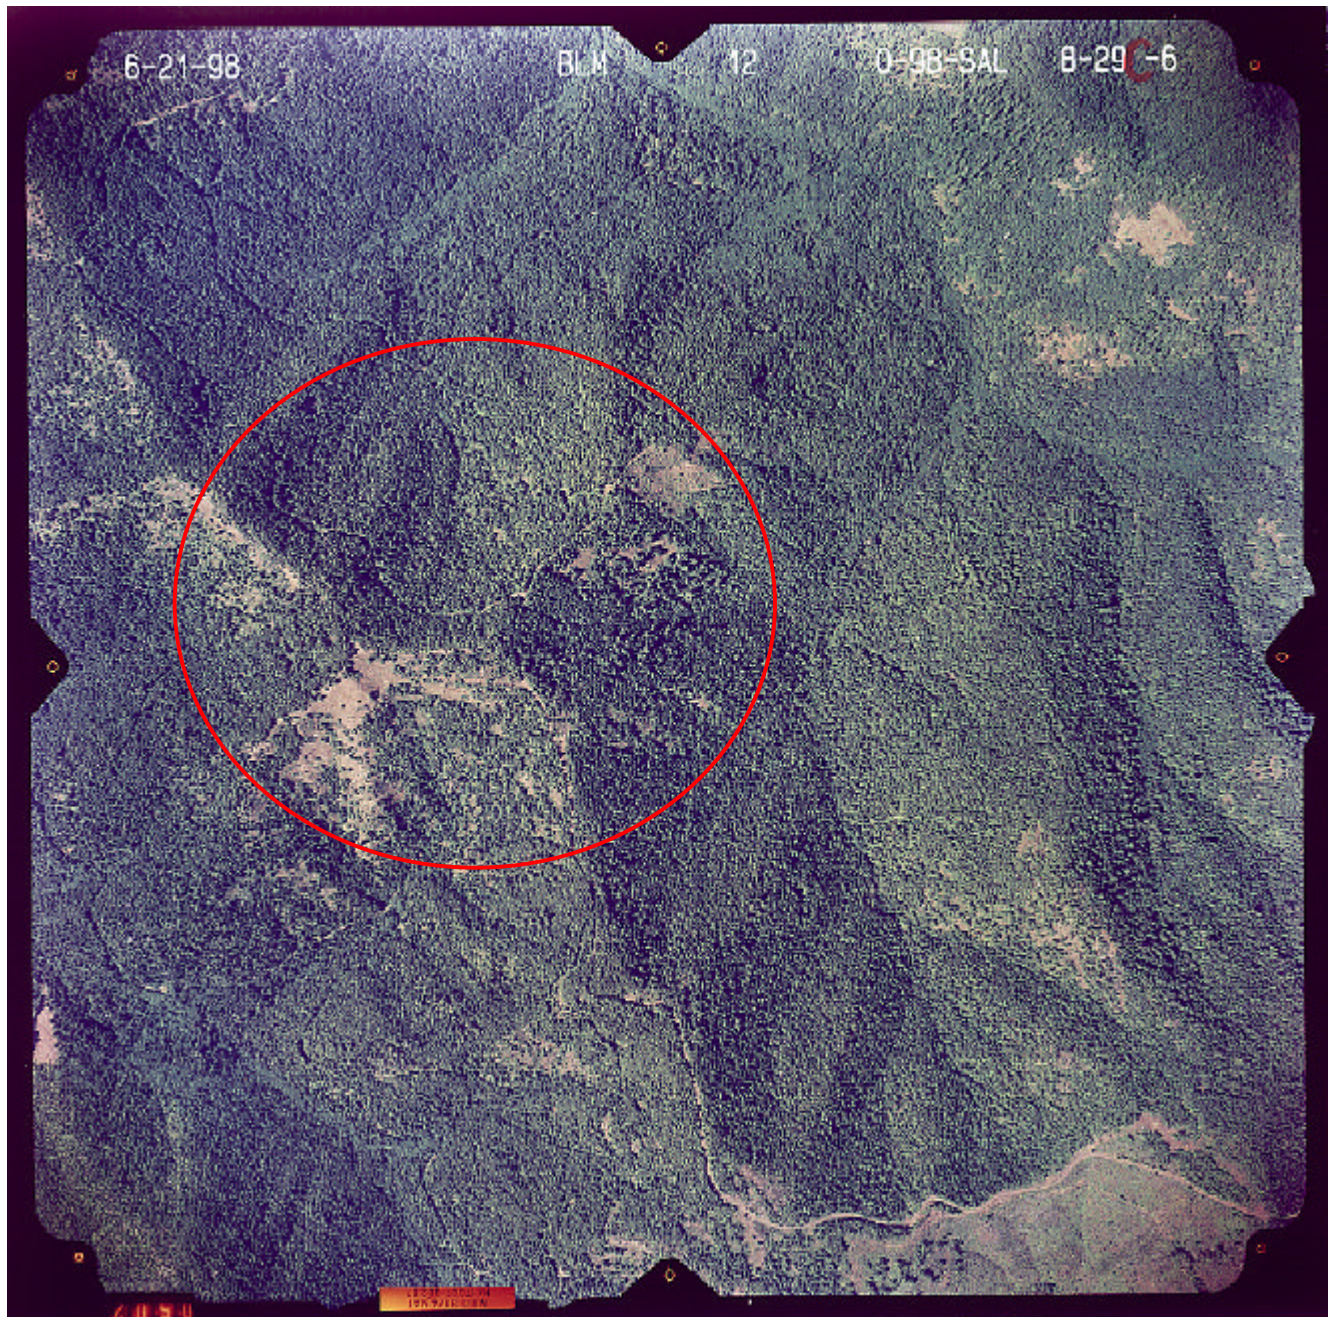
Location on 1998 aerial photo

Description A: About 30 acres, feathers into narrow meadows to east and west, where thin soil has precluded conifer establishment. Very dry site, dry meadow and rock garden. Vegetation includes oceanspray, hairy manzanita, northern buckwheat, dogtail grass (80% cover), silver hairgrass, and much racomitrium moss, TODI, HYPPE, and ACMIL.

Vegetation condition: surface rock, very dry, short vegetation, but areas of shrub and small oaks where soil depth permits.

Oak/hardwood: Scattered oak in the edges of the meadow, and strung along ridgetop to east and northwest.

Conifer invasion: Minor, but has had a large impact on shrubs and oaks. Conifer invasion is relatively recent and former meadow edge can be restored.

Recommended treatments: Conifer removal.

Fire reintroduction comments: Not good candidates for burning.
